COMPOSITE FAILURE ANALYSIS HANDBOOK  
VOL I - PROGRAM OVERVIEW

R.J. Kar  
Northrop Corporation  
One Northrop Avenue  
Hawthorne, California 90250-3277

February 1992

Final Report for Period January 1987 - October 1990

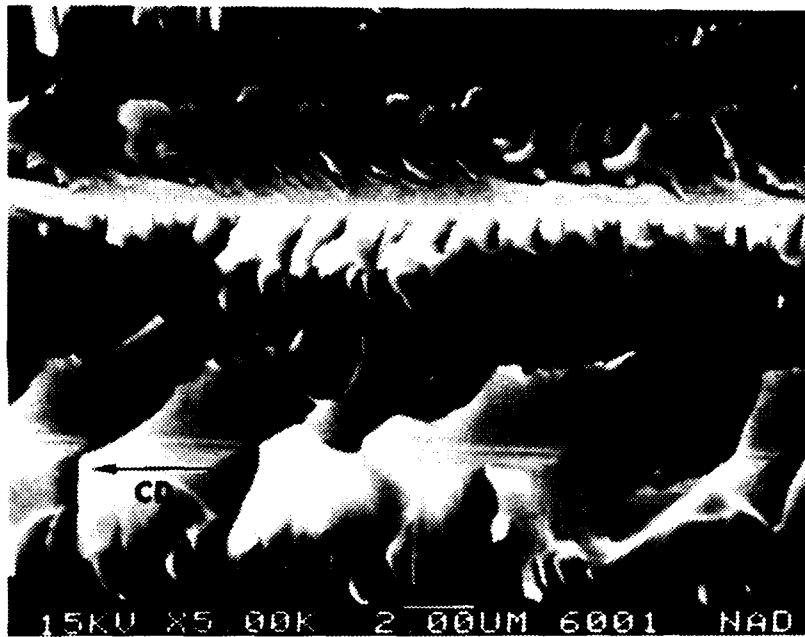
**Figure 3-2. SEM Photograph of Gr/Ep Fracture (Cleaned With Soap)**  
 CD = Crack-propagation direction

Figure 3-2 shows the effect of cleaning with 5 percent NOX soap as indicated in Method 6 above. Figure 3-3 shows the effects of cleaning jet fuel off the fracture surface with acetone. Figure 3-4 shows the effects of cleaning hydraulic fluid with acetone. All the cleaning methods worked well on Gr/Ep composite fracture surfaces and to the same extent on all specimens. Contaminants such as hydraulic fluid or jet fuel could be successfully removed from the fracture surfaces without damage to the fracture detail. No fracture surface artifacts were caused either by jet fuel, hydraulic fluid or the cleansers.

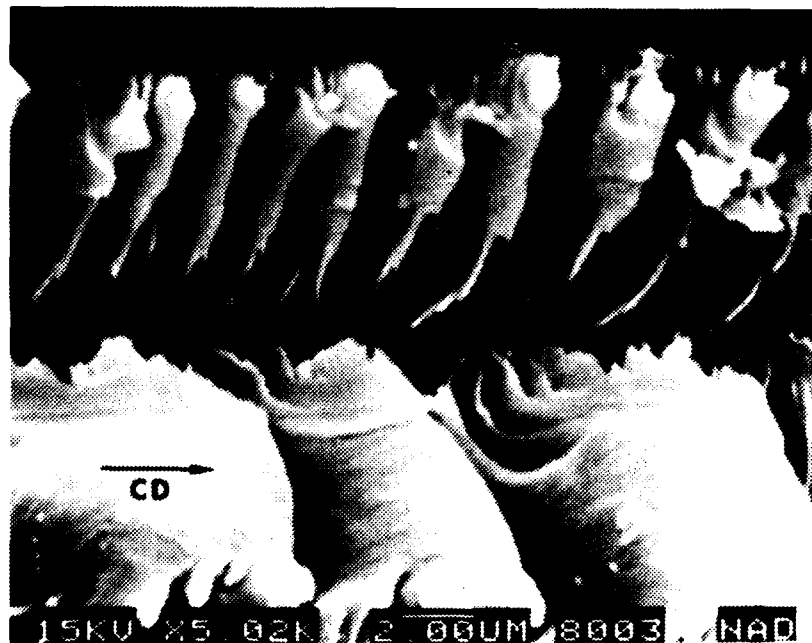
**Figure 3-3. SEM Photograph of Gr/Ep Fracture (Jet Fuel Immersed and Acetone Cleaned)**  
 CD = Crack-propagation direction

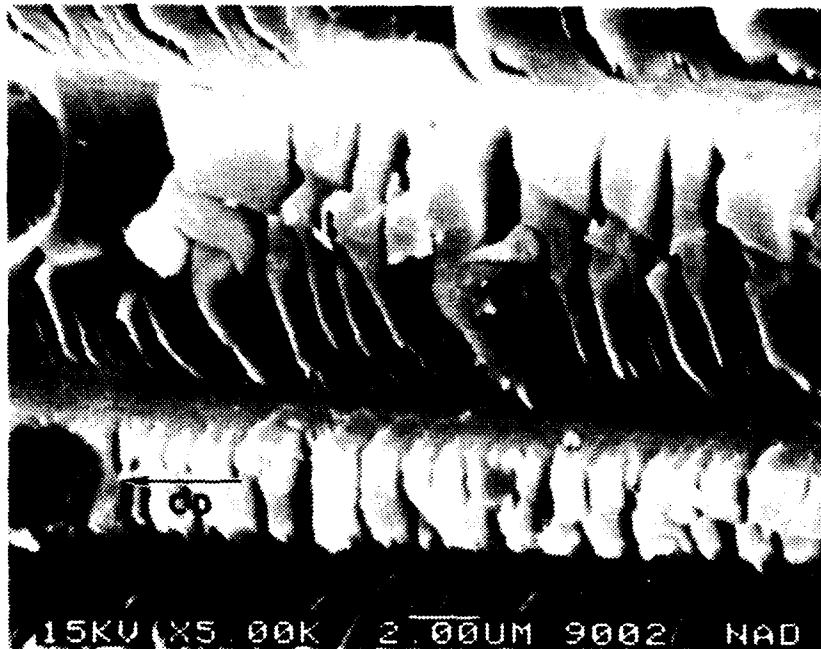
**Figure 3-4.** SEM Photograph of Gr/Ep Fracture (Hydraulic Fluid Immersed and Acetone Cleaned)  
 CD = Crack-propagation direction

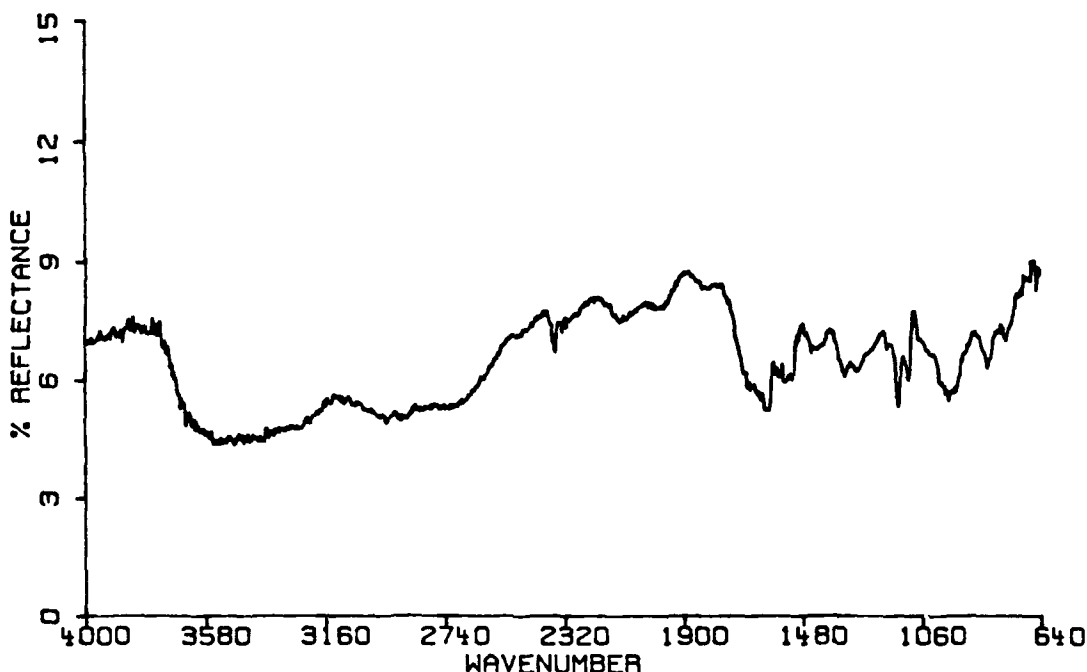
SAMPLE 1: TEST REGION. LOC: 126.0,17.5  
 0.90, MODE II, TEFLON. M. D. ENSMINGER  
 05/27/87 16:15:39  
 87.40 SEC. MEAS. TIME  
 DFN = 115 NSK = 0  
 NSD = 200  
 NDP = 6144  
 NTP = 4096

Figure 3-7. FTIR Spectrum (Diffuse-Reflectance Method) of Contaminated Precrack Region in Mode II ENF Specimen (Teflon Contaminated Specimen)

Figures 3-7 and 3-8 show FTIR spectra (diffuse reflectance method) taken from the precrack (contaminated) and crack-growth (noncontaminated) regions of a Teflon contaminated specimen. Both spectra show strong N-H stretch absorption, as well as strong C-H absorption. At wavenumbers around  $1200\text{ cm}^{-1}$ , strong absorption is observed in both spectra, characteristic of the C-O bonds, with unspecified absorption at  $1600\text{ cm}^{-1}$ , believed to be C-O stretch. However, a comparison of the spectra showed that the precrack region was associated with a higher overall reflectance than the crack-growth region. In addition there was greater differentiation below  $1750\text{ cm}^{-1}$ . This increased differentiation is believed to be due to the absorption by the Teflon.

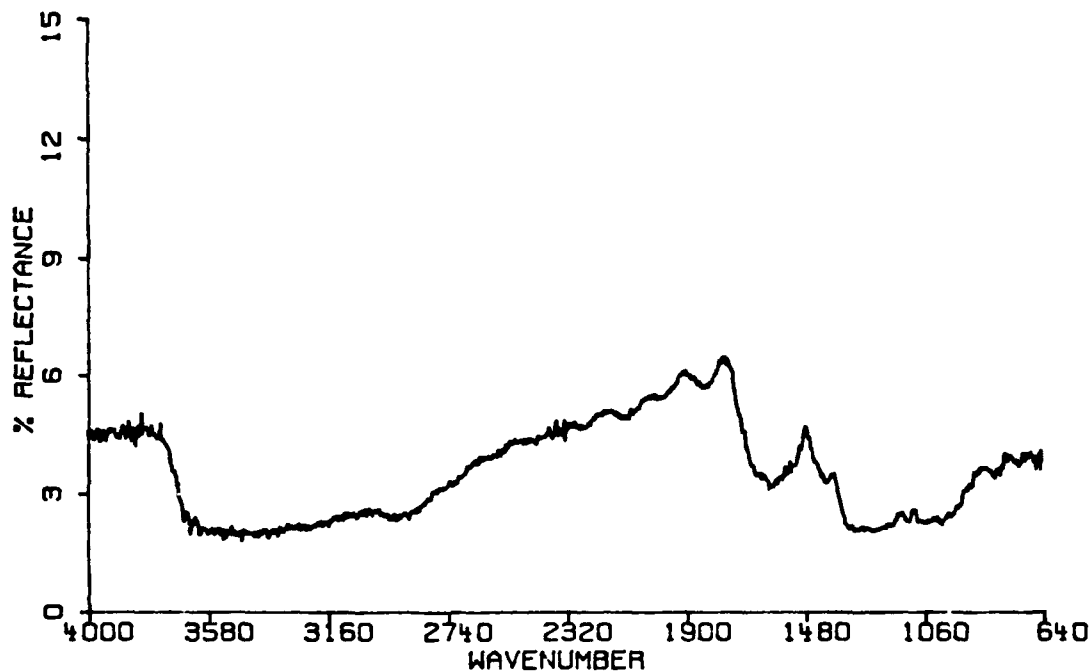
Figure 3-8. FTIR Spectrum (Diffuse-Reflectance Method) of Noncontaminated Pre-crack Region in Mode II ENF Specimen (Teflon Contaminated Specimen)

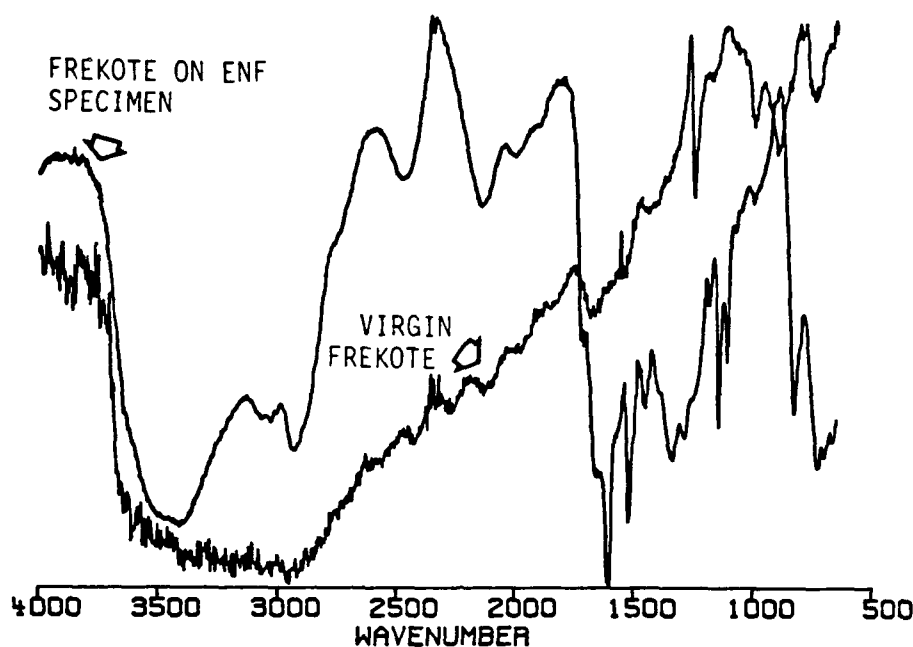
Figure 3-9. FTIR Spectra of Virgin Frekote and Frekote Contaminated Fracture

Figure 3-9 shows FTIR spectra (diffuse reflectance method) taken from virgin Frekote and Frekote from a 90/0 ENF specimen. Figure 3-10 is a comparison of spectra from the contaminated and noncontaminated regions of the Frekote specimen. As shown by the results, substantial differences existed in the characteristic stretches of all three spectra. The differences between virgin Frekote and Frekote on the fracture were believed to be due to the cure and post-cure treatment carried out on the Gr/Ep laminate from which the ENF specimen was fabricated. These results also indicated that direct comparisons of spectra from contaminants, such as Frekote, with those from virgin material would not be sufficient for a chemical failure analysis investigation.

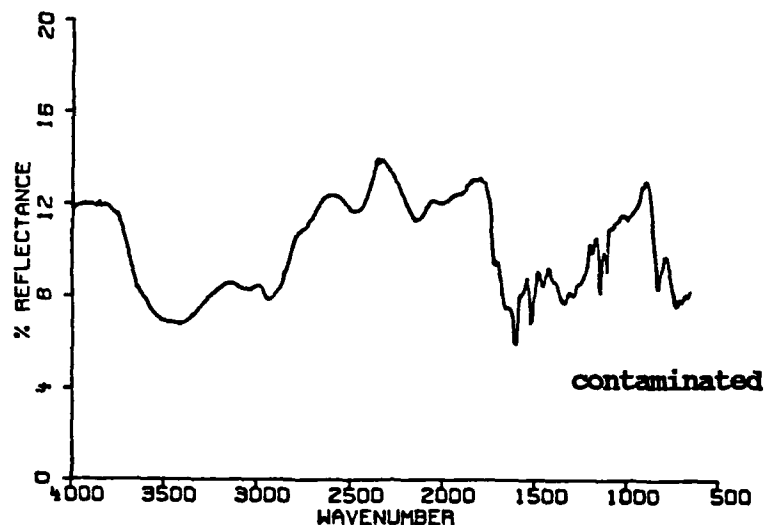
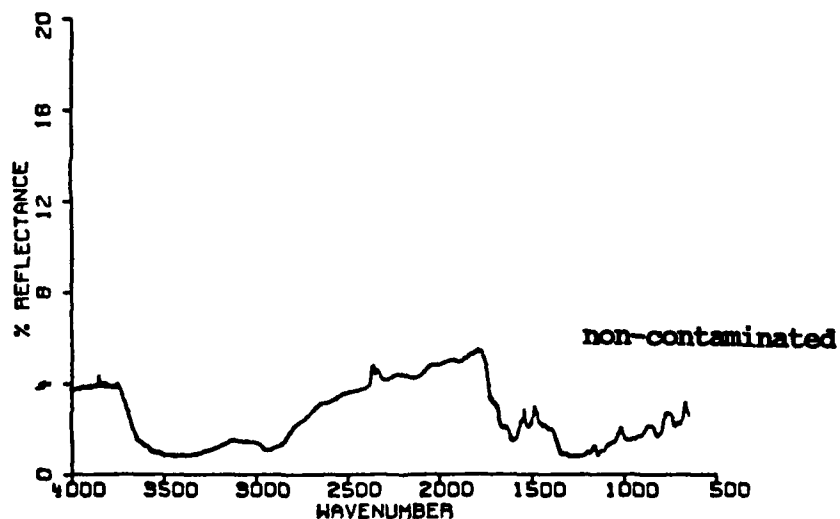
SAMPLE 2: FREKOTE. LOC: C.00.0.00  
 0/90. MODE 11. FREKOTE. PRECRACK REGION. LOC IS LOWER RIGHT COR  
 06/11/87 10:42:56  
 872.59 SEC. MEAS. TIME  
 DFN = 50 NSK = 0 COR = LO  
 NSD = 2000 GAN = 1 VEL = 40  
 NOP = 6144 AFN = HG DET = 2  
 NTP = 4096 APT = FL

SAMPLE 2: FREKOTE. LOC: -10.48.-0.04  
 0/90. MODE 11. FREKOTE. PROPAGATION REGION. LOC: UPPER RIGHT COR  
 06/11/87 14:39:58  
 872.51 SEC. MEAS. TIME  
 DFN = 85 NSK = 0 COR = LO  
 NSD = 2000 GAN = 1 VEL = 40  
 NOP = 6144 AFN = HG DET = 2  
 NTP = 4096 APT = FL

Figure 3-10. FTIR Spectra of Frekote Contaminated and Noncontaminated Regions in ENF Specimens

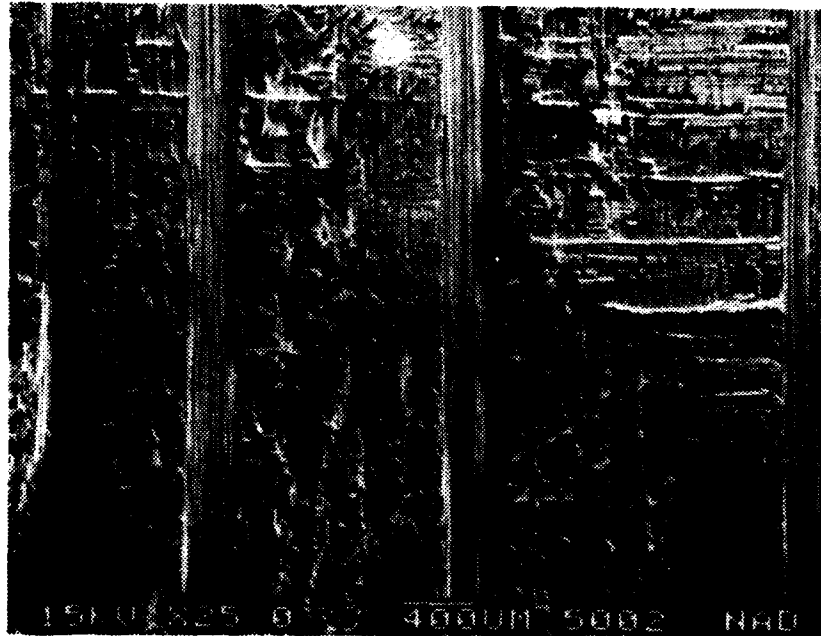
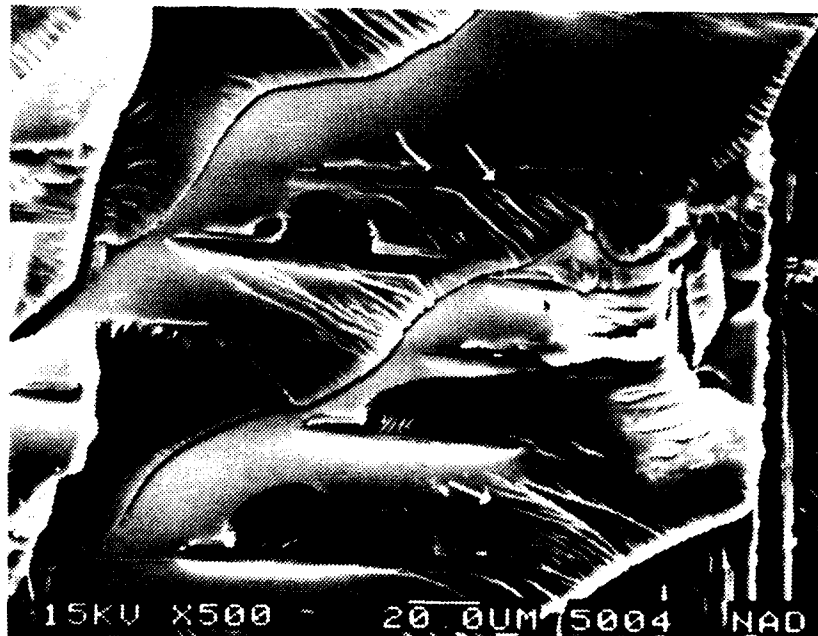
**Figure 3-12. SEM Photographs of Delamination Fracture in Impacted Specimen**  
Note river patterns shown by arrows

SEM examination of the impacted region indicated that the fracture surface was characterized by delamination fracture at a 0/90 interface. The fractured resin was decorated with river-patterns that extended radially outwards, as shown in Figure 3-12. The specimen was examined using this technique and the fracture propagation directions were mapped from the site of impact. Figure 3-13 illustrates the mapped crack-propagation directions observed by SEM analysis. It was determined through examination of the fracture features that crack-propagation occurred radially in the delamination caused by impact.

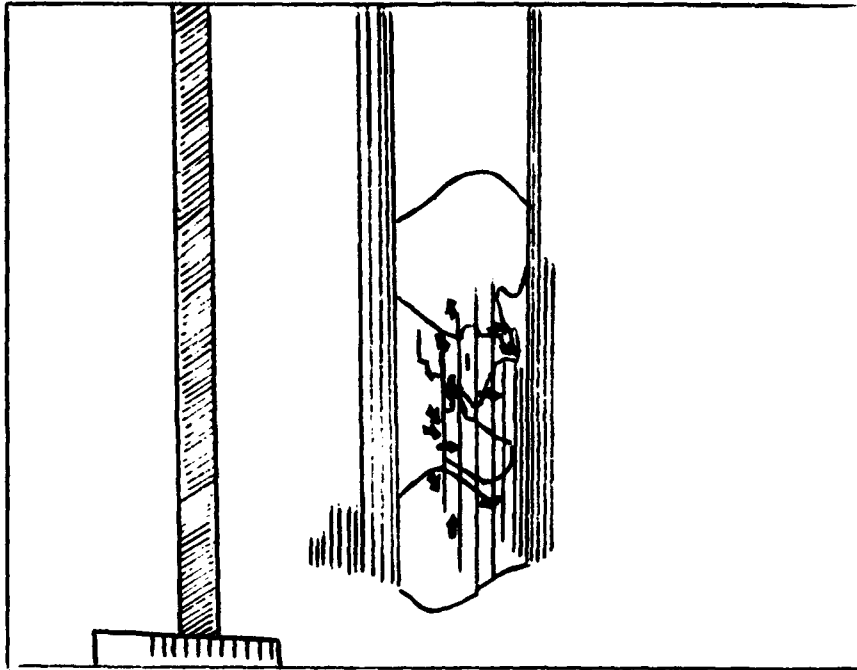
**Figure 3-13. Mapping of Crack-Propagation (Arrows) in the Delamination Region of the Impacted Specimen (I = Impact Point)**

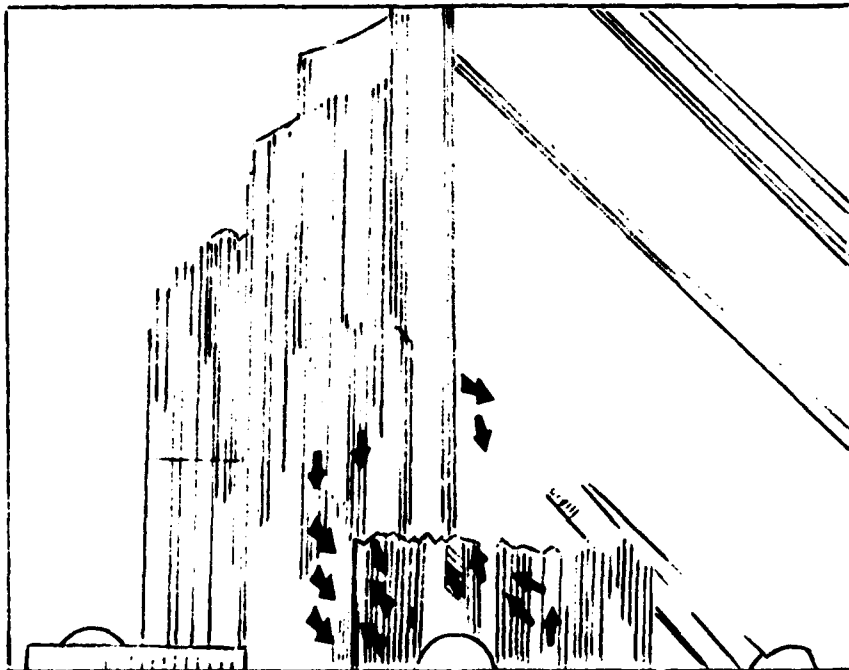
**Figure 3-15. Mapping of Crack-Propagation Direction (Arrows) in Delamination Region of Multispar Panel**

Figure 3-14, the impact-damaged region again had a unique visual fracture signature that noticeably differed from that of nonimpacted fracture regions. SEM examination could again be used to determine crack-propagation directions in the delamination caused by impact. A mapping of the observed crack-propagation directions in the delamination is shown in Figure 3-15. Note that the spar had a considerable effect on the delamination fracture features caused by impact in that deviations from general radial propagation were observed.

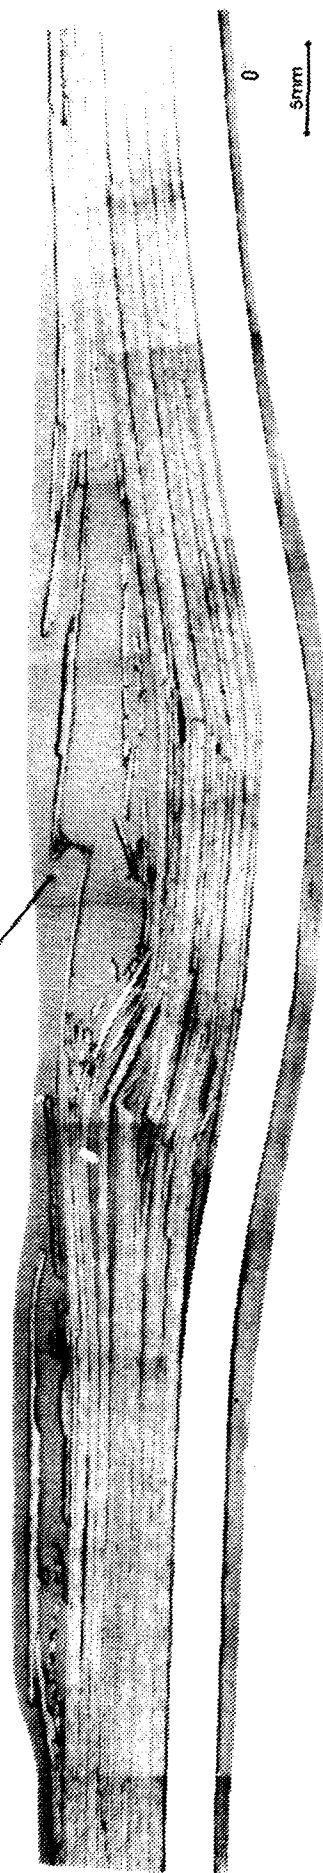
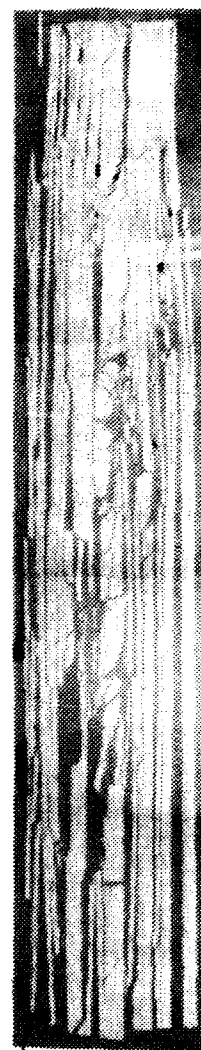
Figure 3-18. Photographic Collage of Impact and PIC Multispar Panel (NAD Specimen No. 2)

Figure 3-18 shows a similar photographic collage of NAD Specimen No. 2, part of a multi-spar Gr/Ep panel that had been impacted and PIC tested. The materialographic sections were prepared as before, normal to the fracture in the direction of the 0, 45, and 90 degree plies, and oriented so that the fractures were in profile. The effect of the bolted joint on the fracture characteristics could be determined by this technique. As shown in Figure 3-18, mechanical joining of the composite to a spar had resulted in the plane of maximum delamination (caused by impact) being shifted closer to the top face of the panel rather than the bottom face, as is normally observed in impact failures.

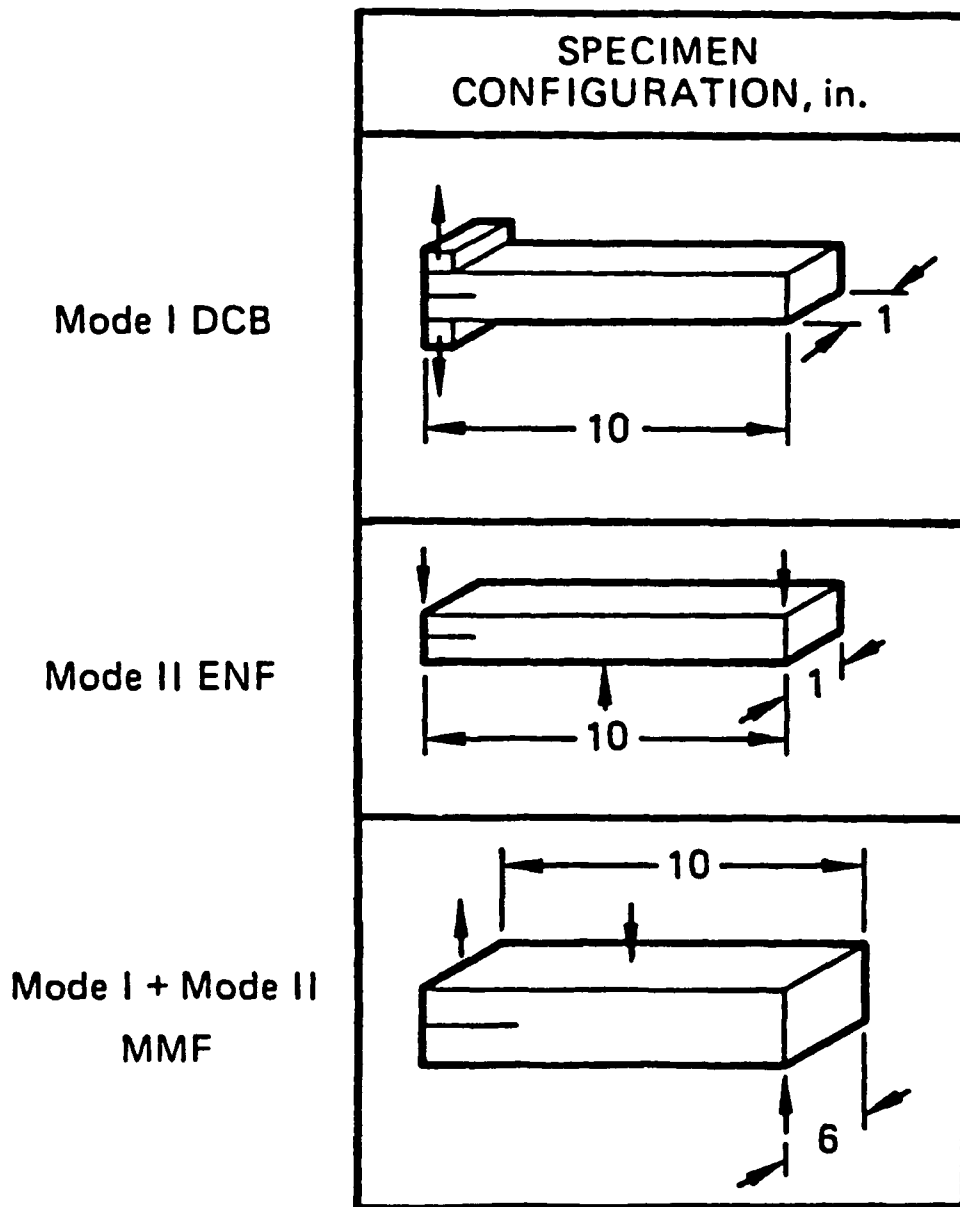
Figure 3-19. Interlaminar Fracture Test Specimens

Northrop fabricated double-cantilever beam (DCB), mixed-mode flexure (MMF), and crack lap-shear (CLS) specimen configurations for interlaminar fracture tests. The dimensions of these specimens are shown in Figures 3-19 and 3-20. The starter cracks were to be obtained through use of Armalon film in the specimens. For translaminar tests Northrop proposed use of four-point load tension, compression, and side-notched rail shear specimens. These are shown in Figure 3-21. Impact tests were to be performed with a blunt one-inch diameter hemispherical impactor.

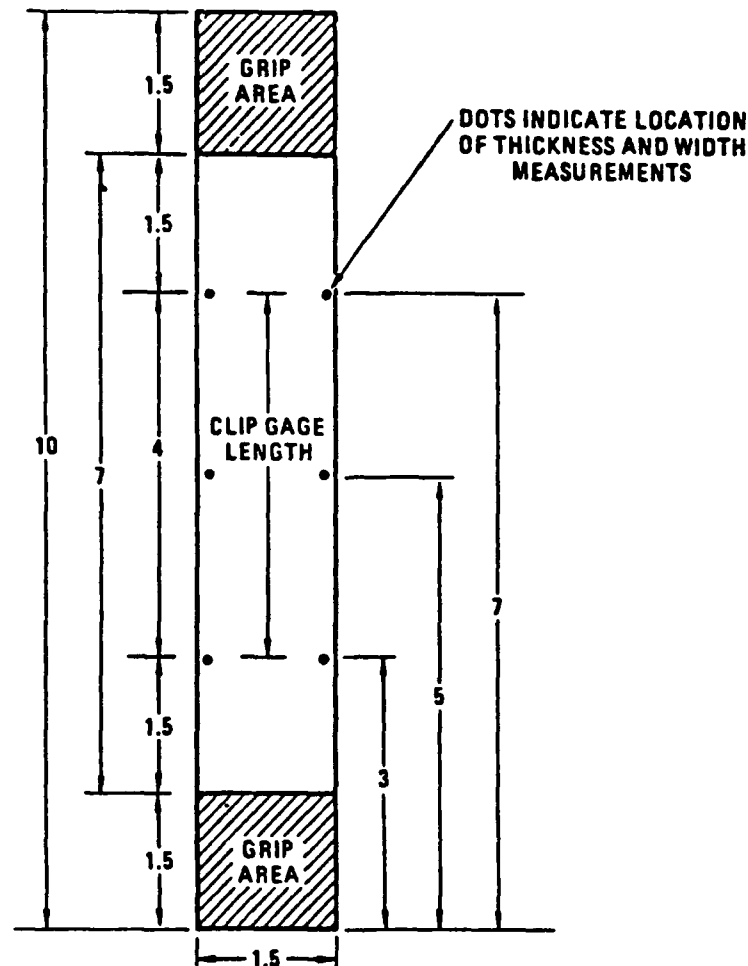
Figure 3-20. Crack-Lap Shear Specimen (All Dimensions in Inches)

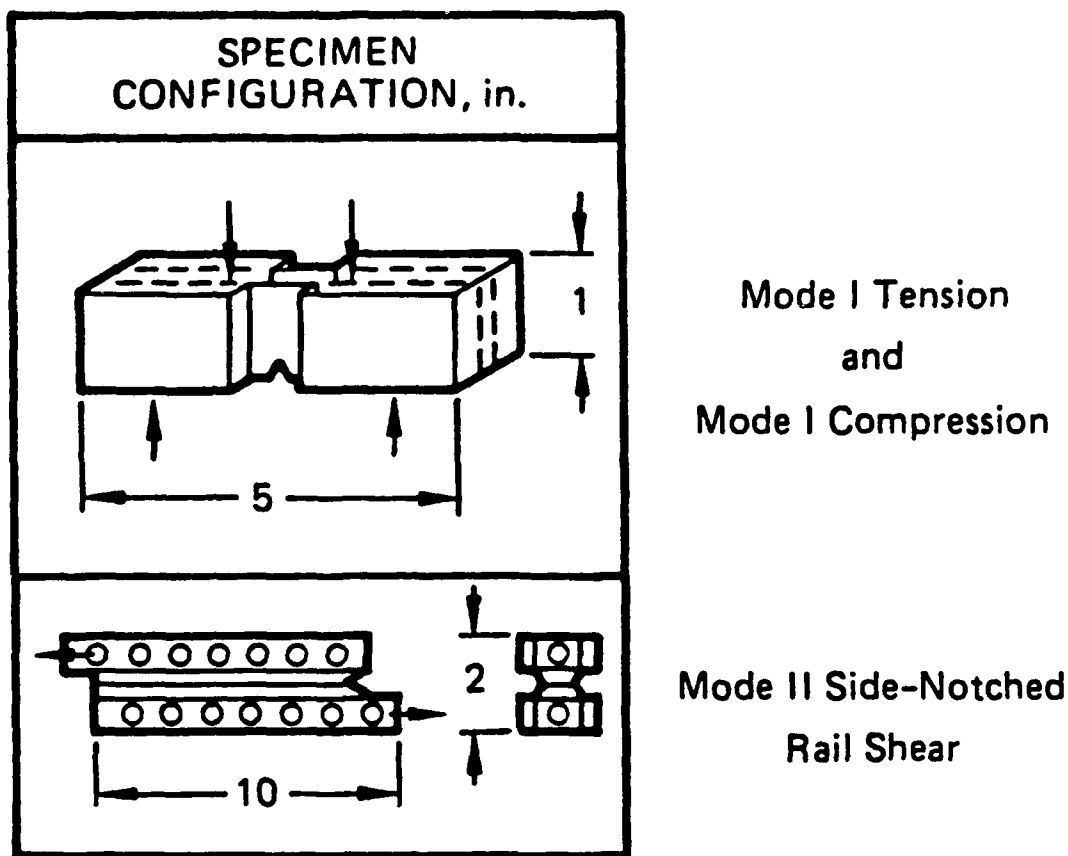
Figure 3-21. Translaminar Fracture Test Specimens

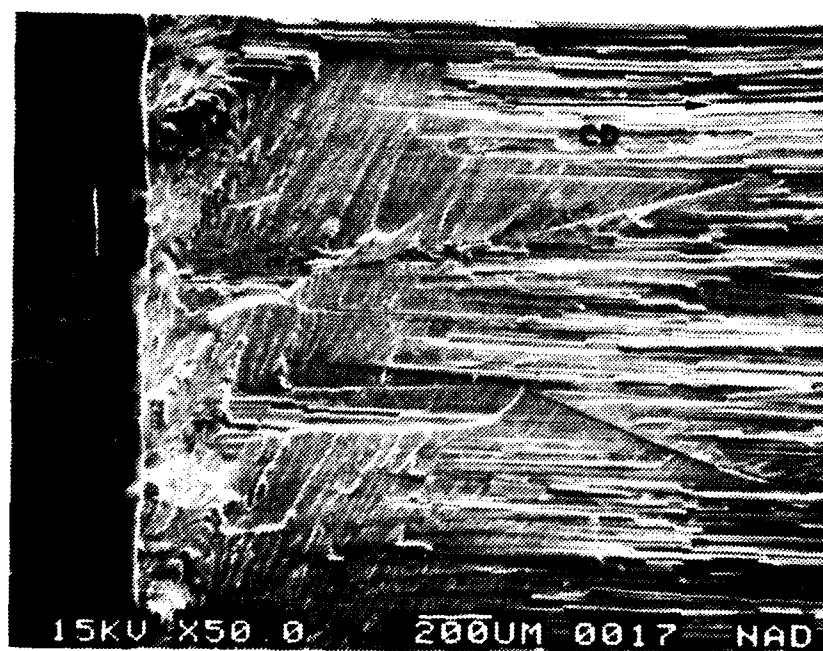
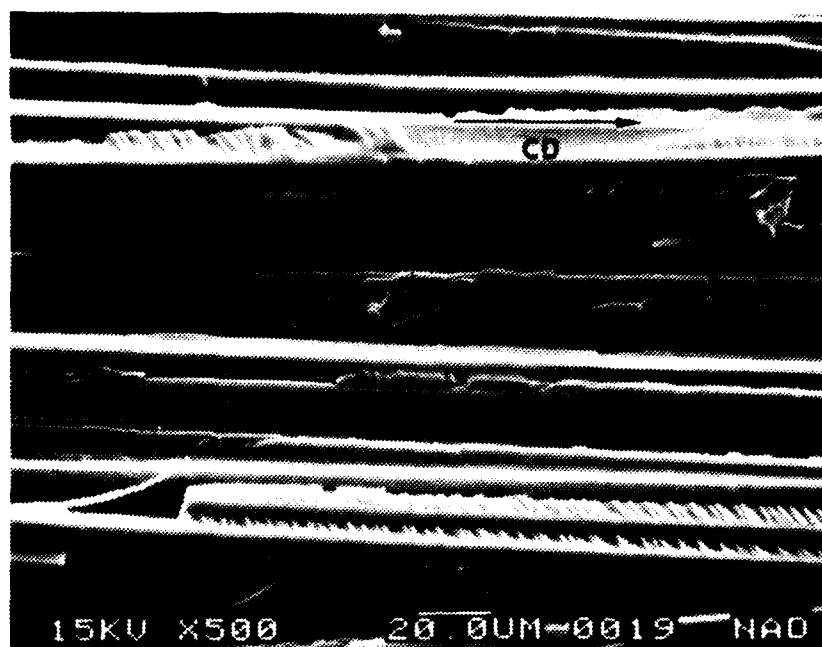
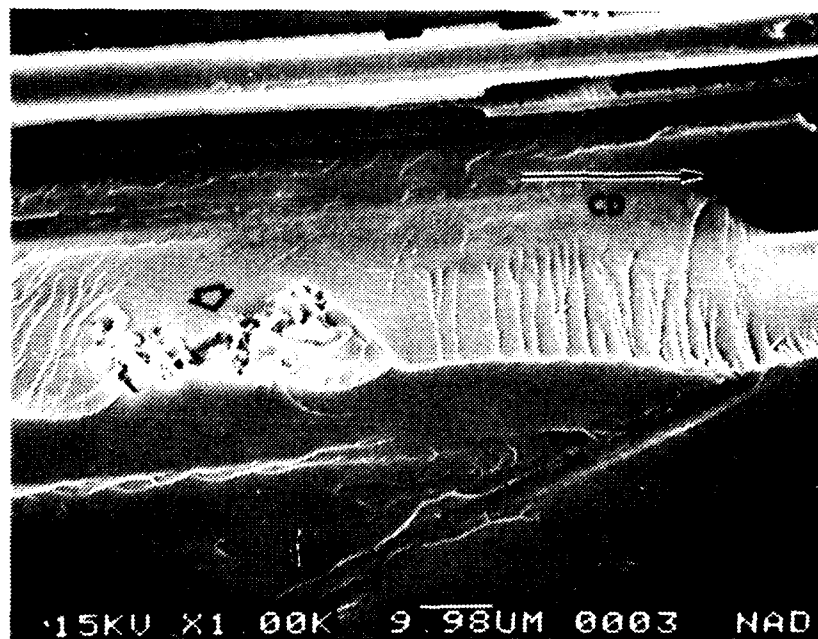
**Figure 3-22. Optical and SEM Photographs of Mode I DCB Interlaminar Fracture in Undercured Gr/Ep - [0]<sub>24T</sub>**  
 (a) Macrophotograph Showing Regions I, II, and III  
 (b) Initiation in Region I Adjacent to Armalon (A)

Figure 3-22. (Continued)  
 (c) River Patterns Indicating Crack-Propagation Direction  
 (d) Porosity (Arrows)

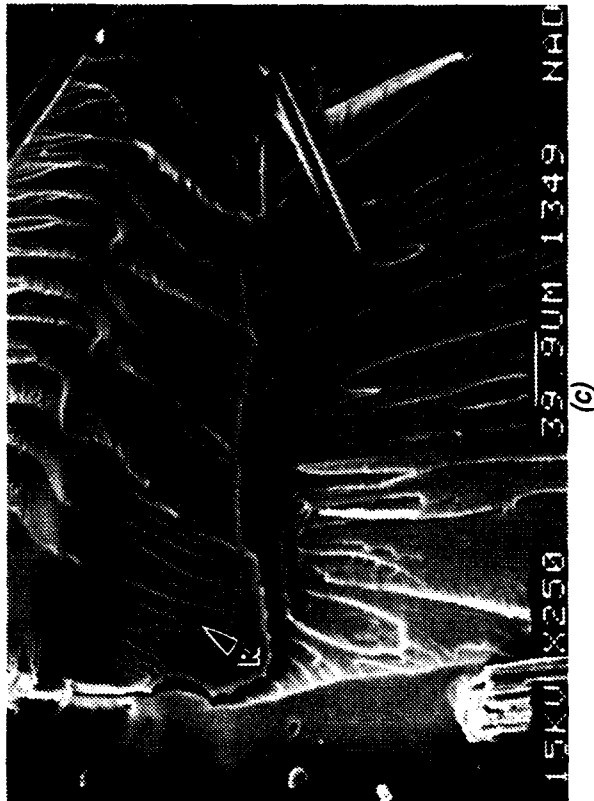
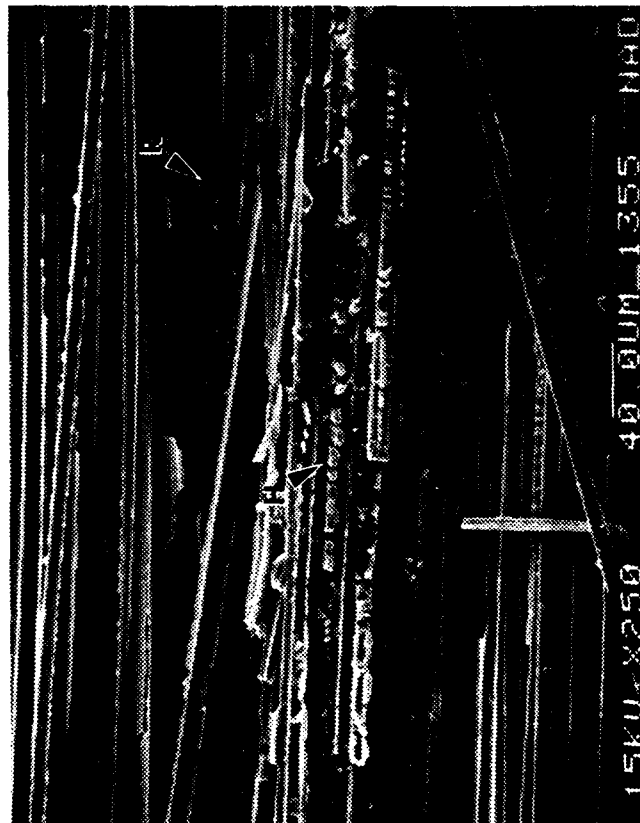
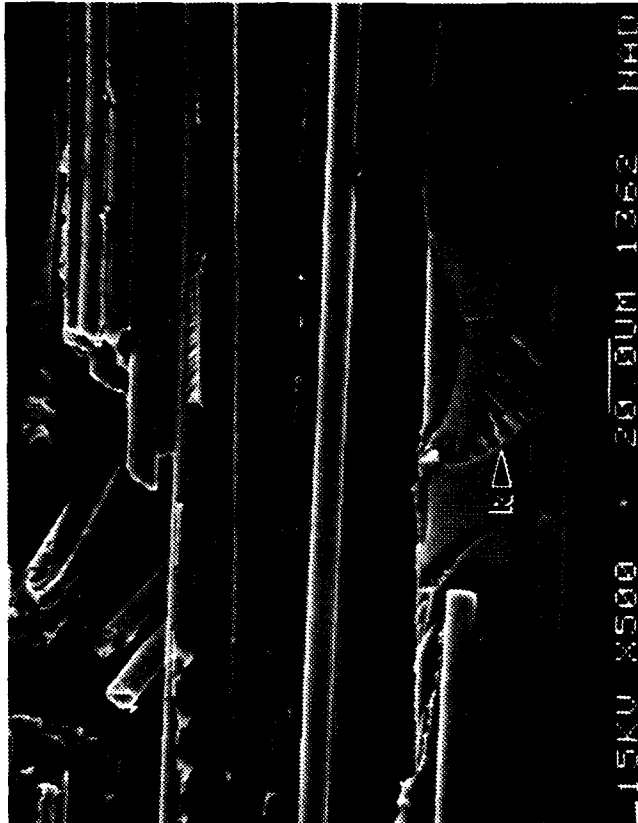
Figure 3-23. Optical and SEM Photographs of Mode I DCB

Impact Damaged Gr/Ep - [0]<sub>24T</sub>

(c) River Patterns (R) in Mode I Region

Figure 3-23. (Continued)  
 (d) Impact Center  
 (e) Broken Fibers in Impact Area  
 Note river patterns in resin

H = Hackles (cusps)  
 R = River patterns

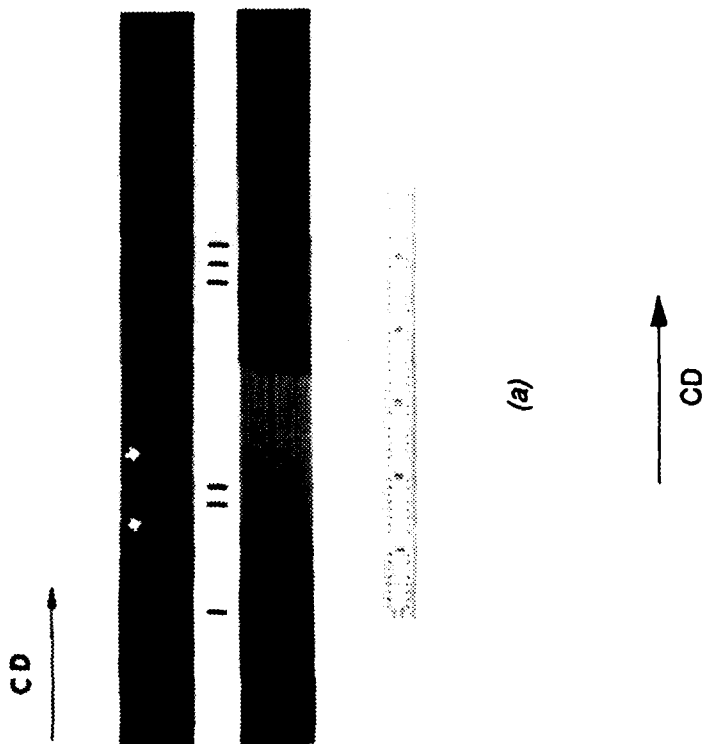
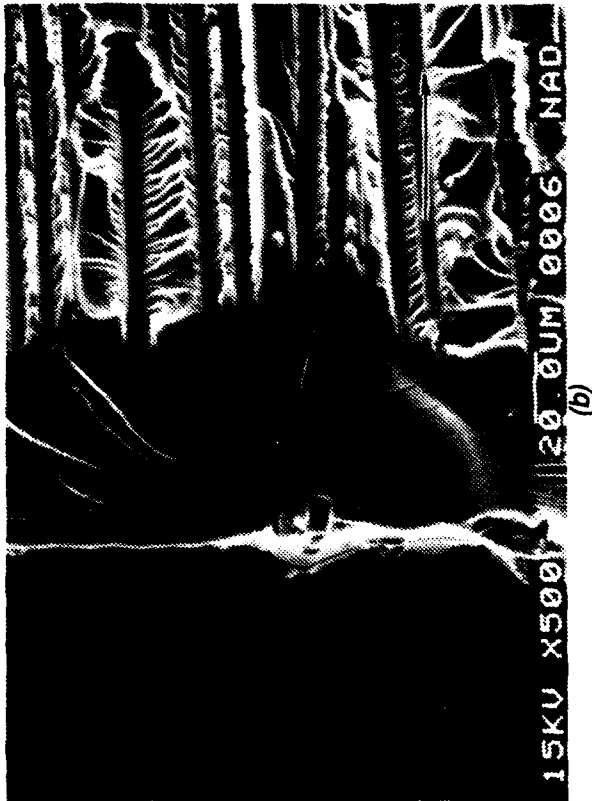
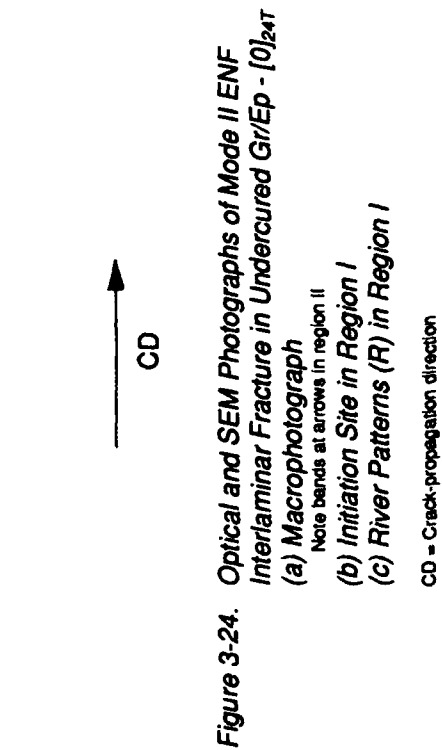
Figure 3-24. Optical and SEM Photographs of Mode II ENF Interlaminar Fracture in Undercured GI/Ep - [0]<sub>2</sub>T

(a) Macro photograph  
Note bands at arrows in region II

(c) River Patterns (R) in Region I

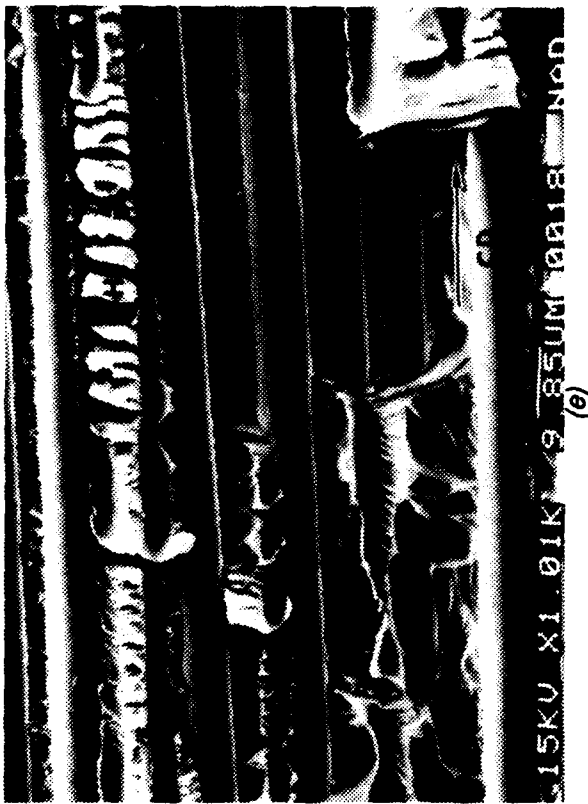
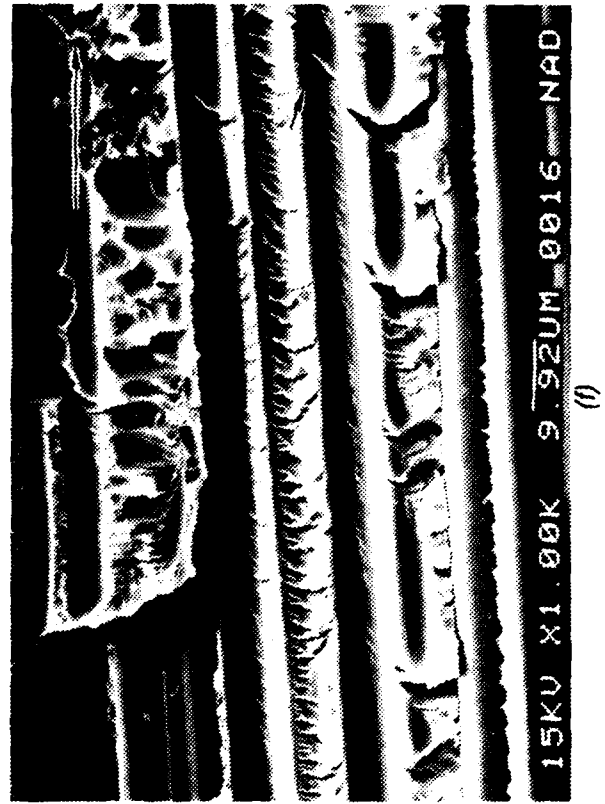
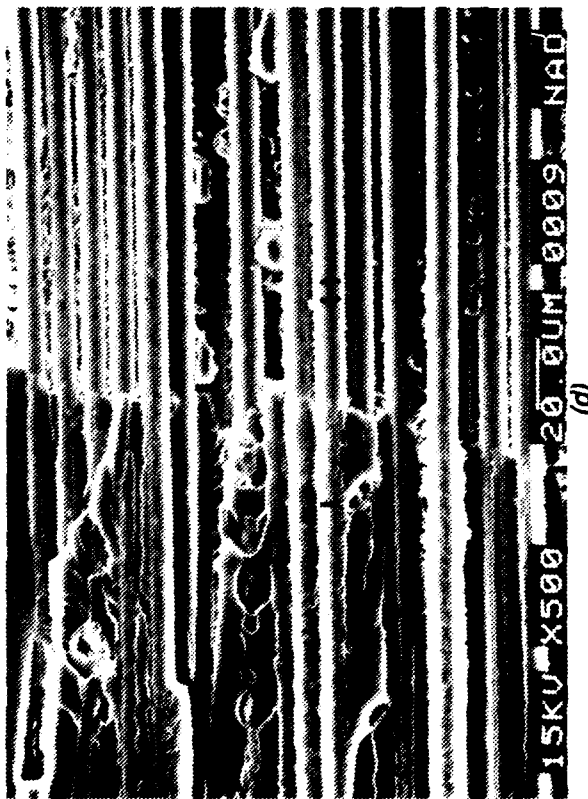
Figure 3-24. (Continued)  
 (d) Region I/II Interface  
 (e) Hackles (H) and Scallops (S) in Region II  
 (f) V-Shaped Tears in Region II  
 CD = Crack-propagation direction

Figure 3-24d presents a SEM photograph of the Region I/Region II boundary. Pronounced differences in fracture surface morphology were observed, as illustrated, on transition from Mode I tension to Mode II shear. There were no unique features at the boundary, such as chevrons or radial lines indicative of Mode II shear fracture initiation. The features observed in Region II consisted of hackles and scallops of various shapes and sizes (Figure 3-24e). The crack-propagation direction could not be established based upon the inclination(s) of the hackles. As illustrated in Figure 3-24f, a few fractured resin troughs (where fibers had pulled out) and fractured resin on individual fibers had V-shaped tears oriented in the macroscopic crack-propagation direction. However, these features were not frequent enough to unequivocally map the crack-propagation direction.

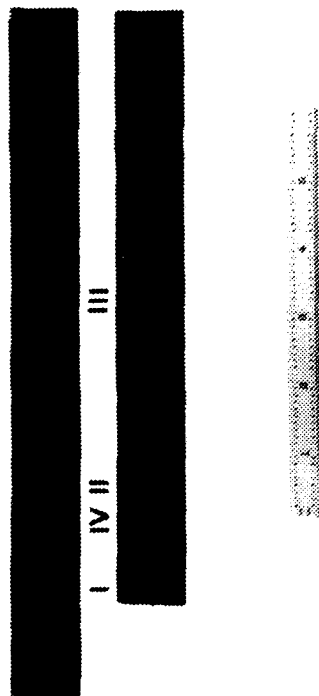
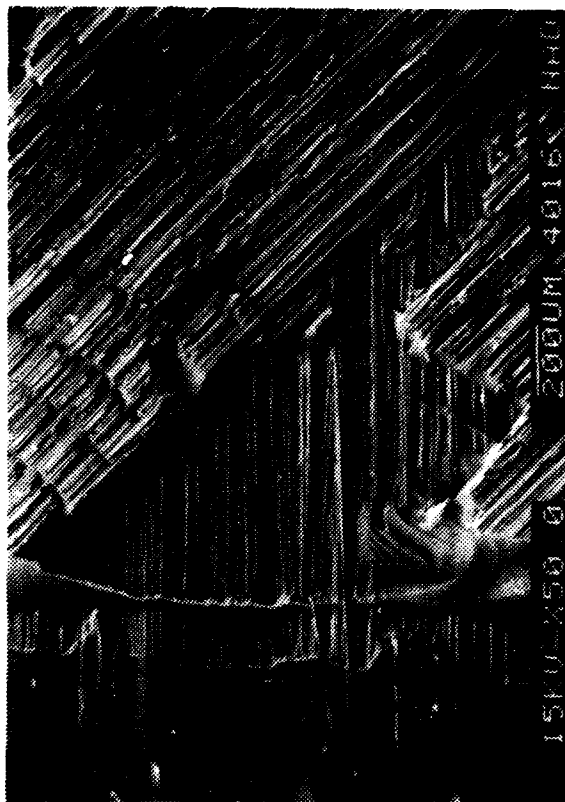
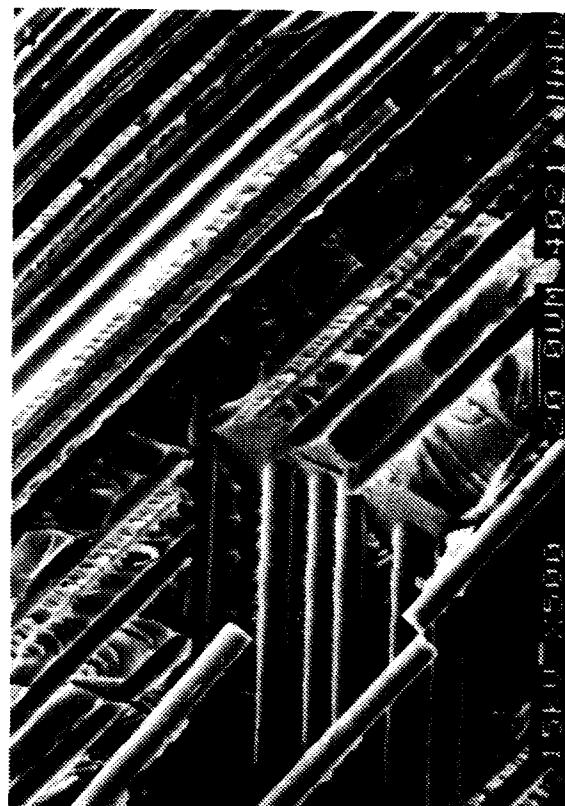
Figure 3-25. Optical and SEM Photographs of Mode I and II MMF Impact Damaged Gr/Ep - [+45/0/-45]<sub>4s</sub>  
 (a) Macro photograph Showing Regions I, II, III and IV (Precrack, Crack Growth Under Mode I Tension and Mode II Shear, Laboratory Overload, Impact Damage)  
 (b) Initiation in Resin-Rich Areas  
 (c) River Patterns in the Mode I Fracture Region

**Mixed Mode Interlaminar Fractography.** Figure 3-25 presents photographs illustrating macroscopic and microscopic fracture features observed in  $[+45/0/-45]_4S$  Gr/Ep that was impact damaged using a one inch diameter hemispherical indenter with a force of 60 inch-pounds. The specimen had been impacted to assess the effect of impact on mixed-mode crack-growth.

As shown in Figure 3-25a, delamination fracture caused by impact had a characteristic macroscopic fracture signature which is easily distinguishable. Regions labeled I and III were Mode I tension interlaminar fractures (precrack and laboratory overload, respectively) whereas Region II was the crack-growth region under Mode I tension and Mode II shear. Region IV was the impact damaged region.

Microscopic examination of Mode I fracture features revealed that initiation occurred in the resin-rich areas between the 0 and 90 degree plies (Figure 3-25b). The crack-propagation direction could be mapped by the orientation of the river patterns, which were initially inclined at an angle to the crack-growth direction (Figure 3-25c), and at larger crack lengths tended to align themselves along the direction of crack-growth. The Mode I area (shown in Figure 3-25c) appeared to show localized hackles and scallops.

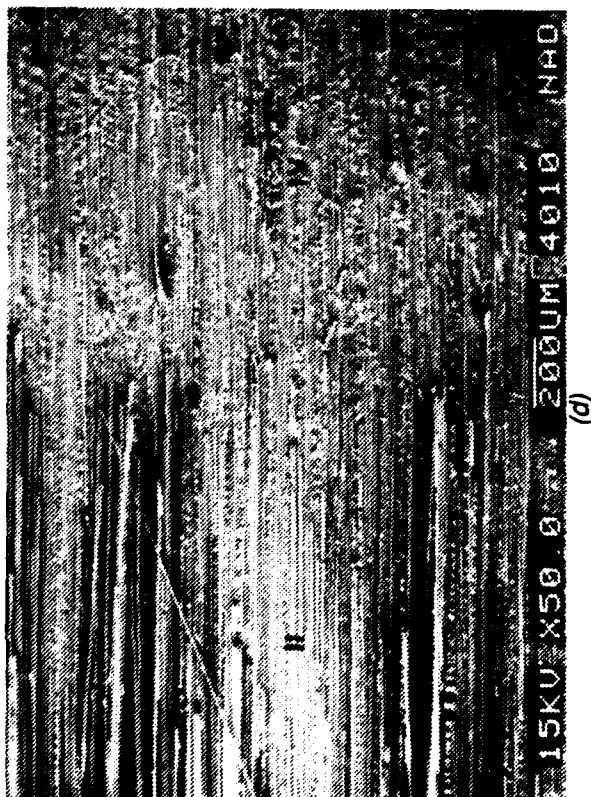
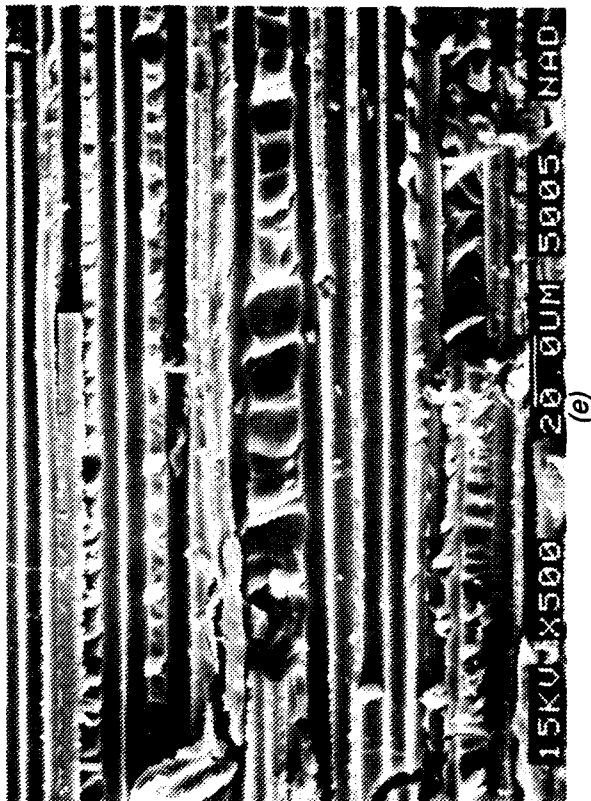
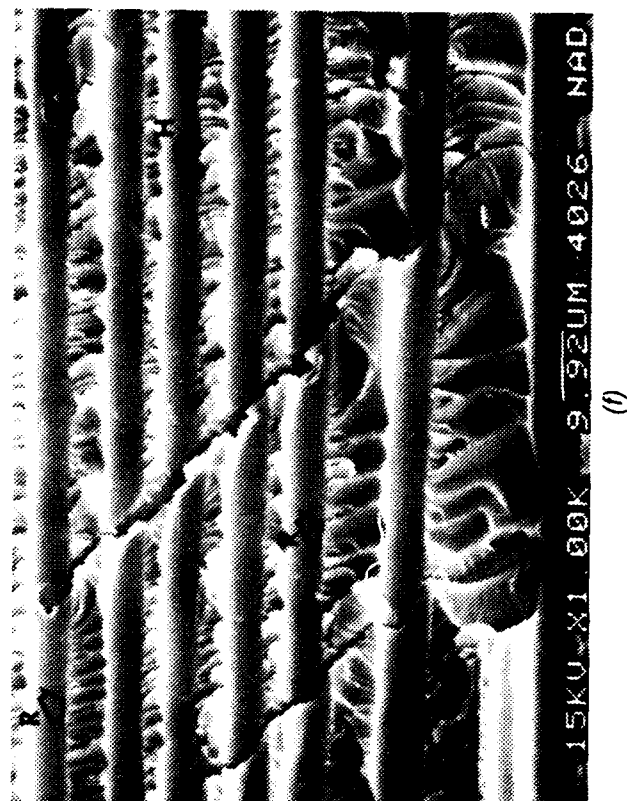
Figure 3-25. (Continued)  
 (d) Interface Between the Mixed-Mode Region II and the Impact Region IV  
 (e) Crushed Resin and Debris in the Impact Damaged Area  
 (f) Mode I Tension and Mode II Shear Fracture Region

Note the presence of river patterns (R), hackles (H), scallops (S) and localized cracks

Figure 3-25d shows a low magnification photo of the mixed-mode and impact damaged regions. Impact (Region IV) could easily be distinguished and differentiated from Region II (crack-growth area). Figure 3-25e shows microscopic fracture details in the impact damaged region. Crushed resin and debris were present among the hackles, scallops and river patterns within the impact damage zone. Mapping of the river patterns, which would indicate delamination due to impact, was complicated by the river patterns present in the Mode I tension and Mode II shear fracture.

Examination of Region II (crack-growth areas under Mode I tension and Mode II shear) revealed river patterns interspersed between subdued hackles and scallops as previously reported for other mixed-mode variable conditions. The macroscopic crack-growth direction could be mapped in these areas from the orientation of the river patterns (Figure 3-25f). Examination of the fracture surface propagated under Mode I tension and Mode II shear revealed the presence of localized parallel cracks which were at a 45 degree angle to the crack-propagation direction (Figure 3-25f) which were extremely similar to those reported by Boeing for mixed-mode fracture in Gr/Ep.
